The Big Bend Reach of the Rio Grande

Addressing Ecological Decline
Along a Hydrologically Altered
Border River

Mark Briggs, World Wildlife Fund

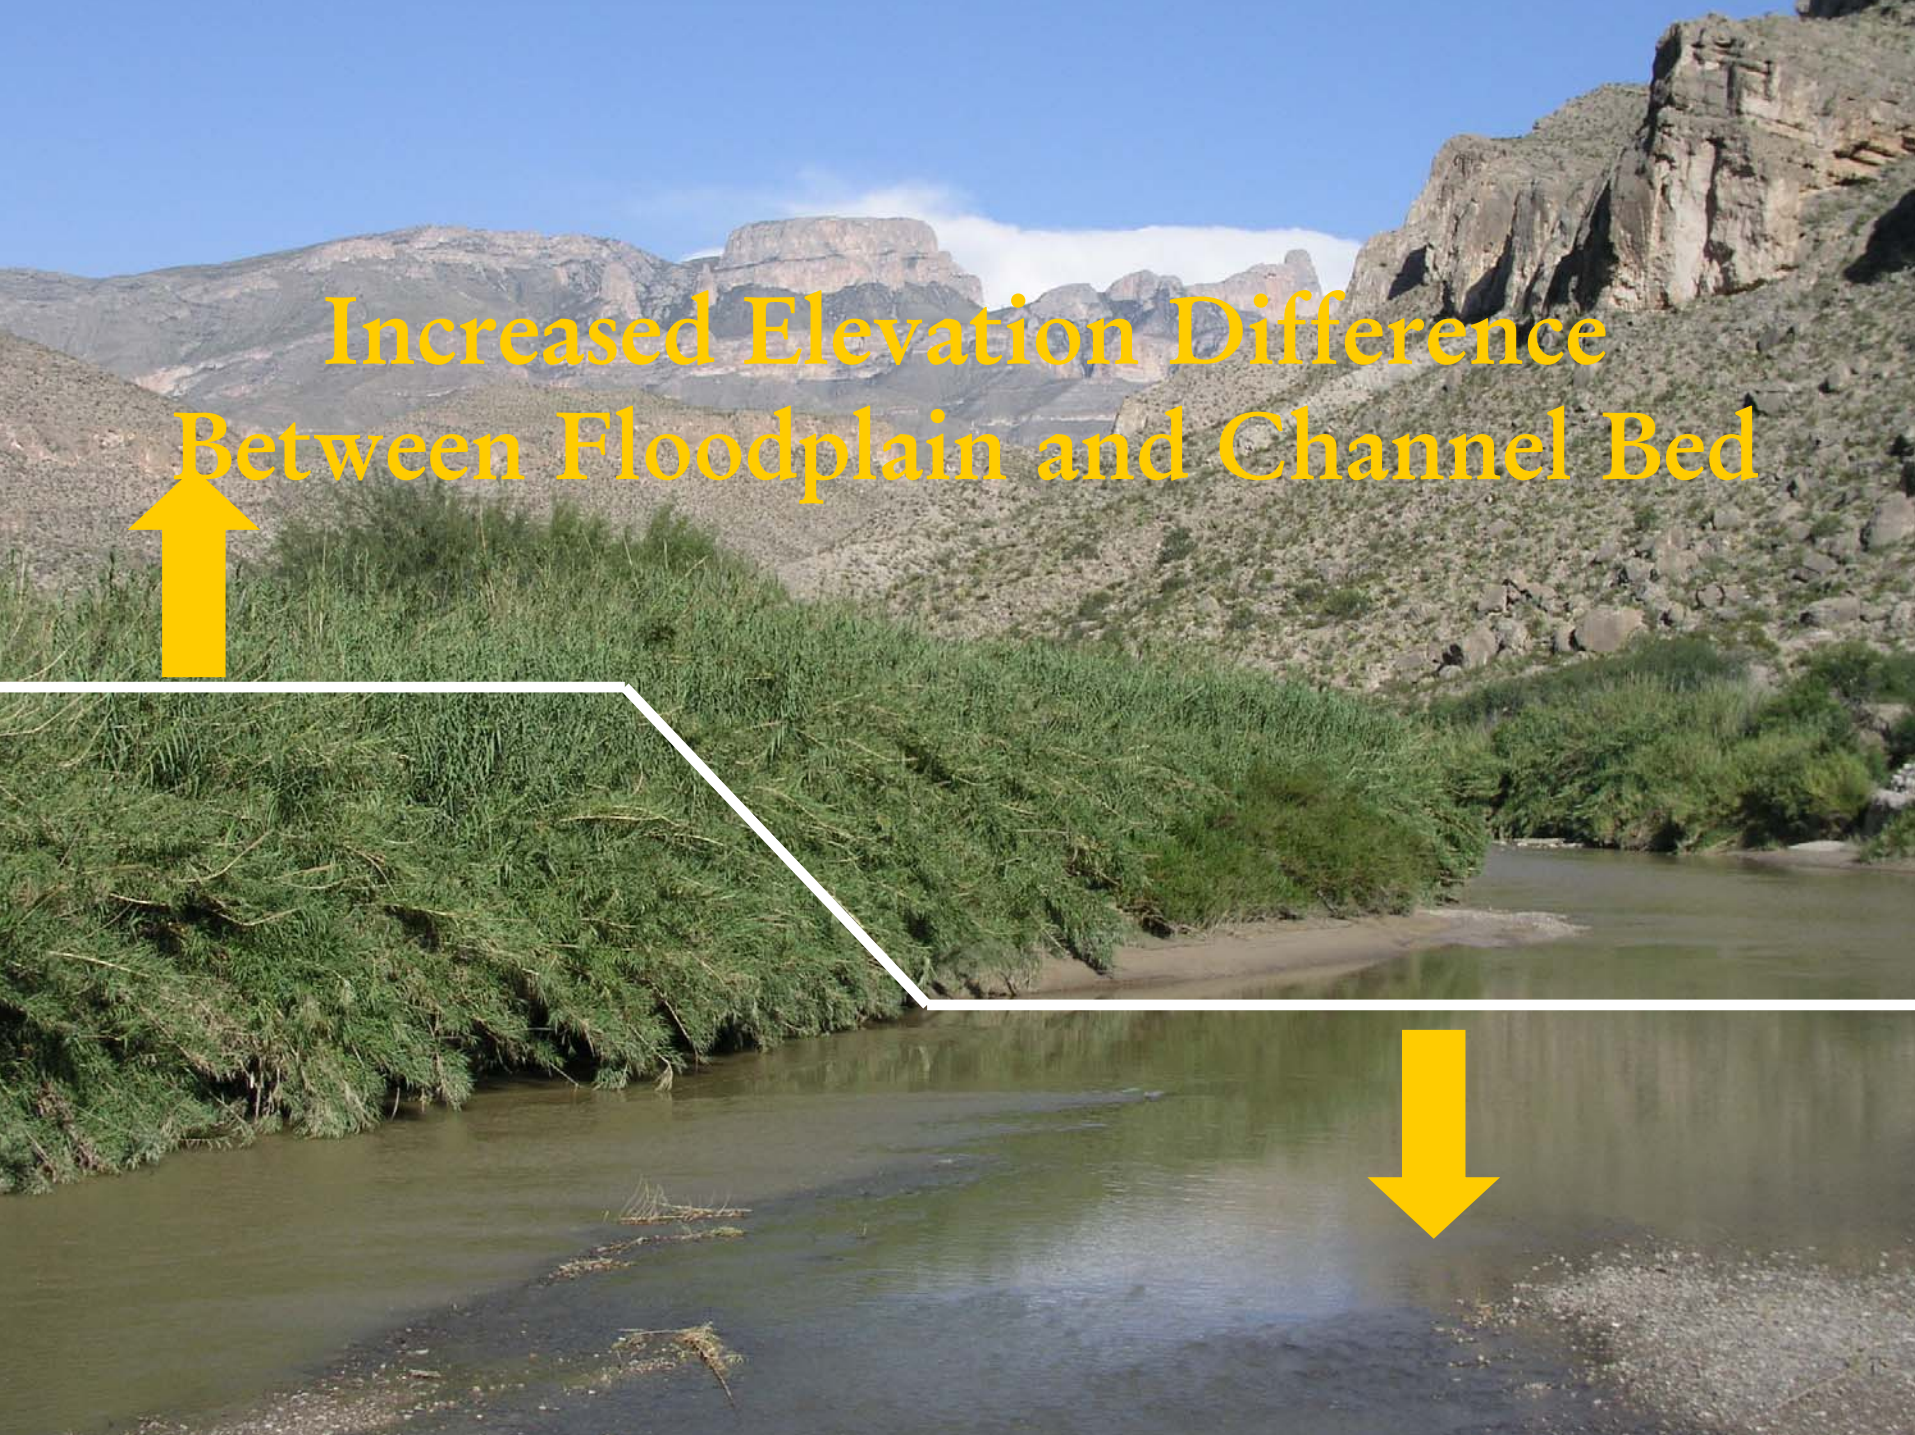
quasi abandoned floodplain surfaces

steep channel banks

minimal floodplain surfaces

Increased Elevation Difference Between Floodplain and Channel Bed

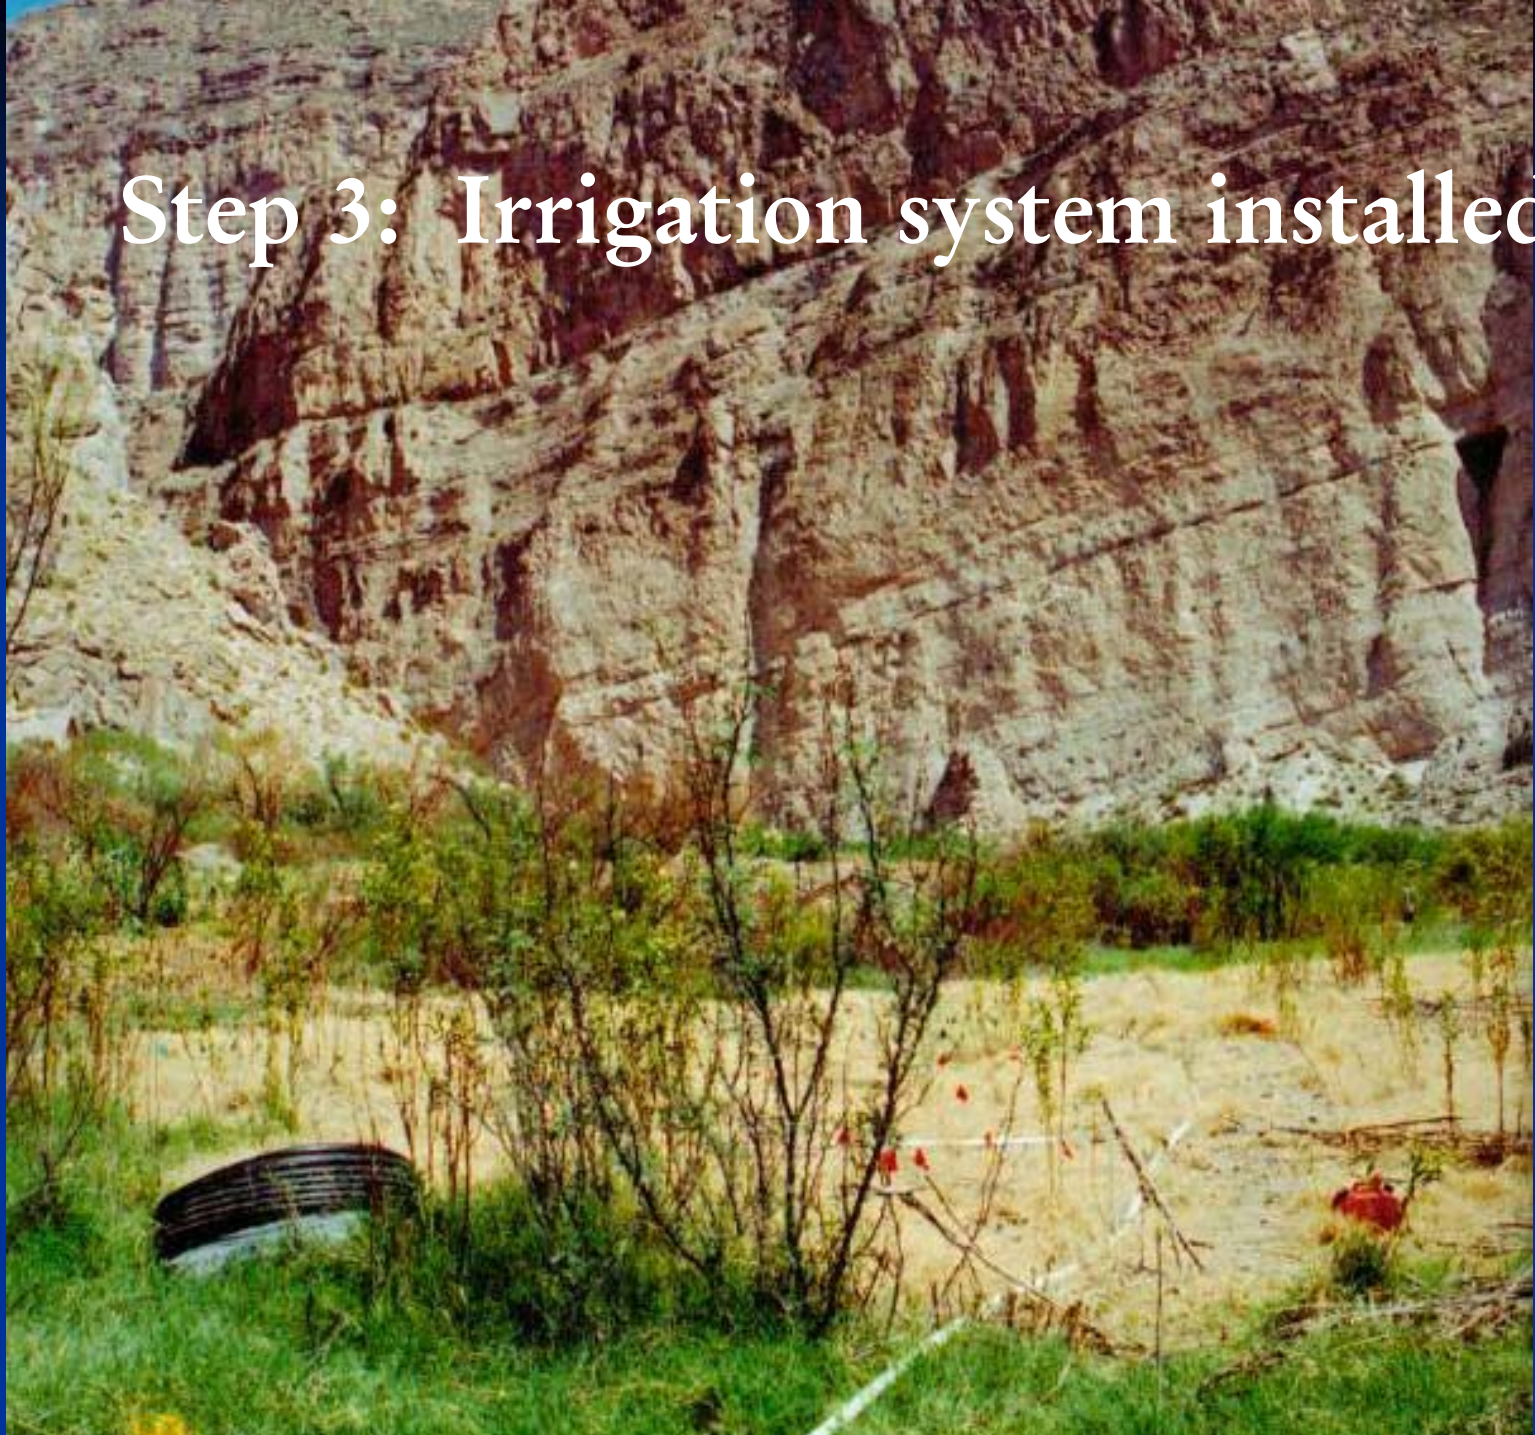
**Step 4: Individual plant sites
augered**
